# Corrosion onset associated with the reinforcement and secondary phases in B<sub>4</sub>C-6061Al neutron absorber material in H<sub>3</sub>BO<sub>3</sub> solution

The microstructures in B<sub>4</sub>C-6061Al composite hot-pressed at different temperatures (560 °C, 620 °C) are characterized, and the corrosion behavior of the materials is studied using electrochemical tests and quasi in-situ TEM observations. The composite fabricated at 620 °C is composed of more matrix-reinforcement reaction products (Al<sub>3</sub>BC at the interfaces and MgB<sub>2</sub> in the alloy matrix). Corrosion occurred slightly in boric acid but severely in Cl<sup>-</sup>-containing solution. The B<sub>4</sub>C/Al interface in both samples is preferentially attacked and the MgB<sub>2</sub> dispersions in the high-temperature-pressed composite remarkably promoted the pitting. Dealloying of Mg<sub>2</sub>Si precipitate does not obviously deteriorate the corrosion resistance of the composite.

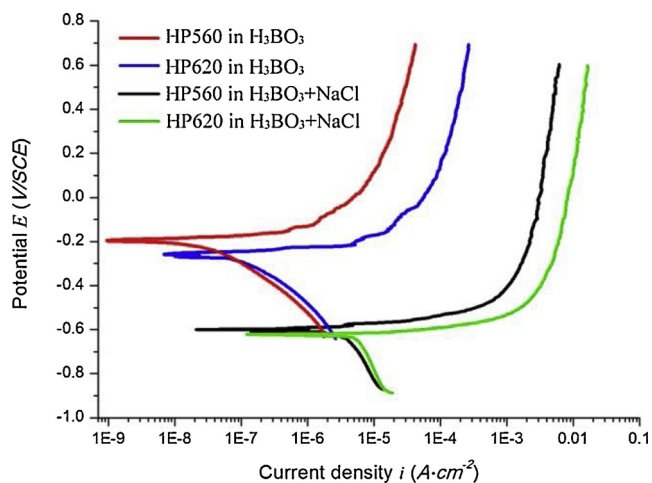
**Fig. 5.** Potentiodynamic polarization curves of the samples HP560 (red) and HP620 (blue) measured in H<sub>3</sub>BO<sub>3</sub> solution. Black and green ones are the polarization curves of the HP560 and HP620 measured in H<sub>3</sub>BO<sub>3</sub> solution with addition of 600-ppm Cl<sup>-</sup>. (For interpretation of the references to colour in this figure legend, the reader is referred to the web version of this article.)

To evaluate the corrosion resistance of the composites, potentiodynamic polarization tests on the above two samples were performed in H<sub>3</sub>BO<sub>3</sub> electrolyte (2500-ppm boron). At least three specimens per condition were measured to ensure the accuracy of tests. The typical polarization curves are displayed in Fig. 5. For the two measured composites, the curve shapes are almost the same. Steep rises in the current were observed at the corrosion potential, suggesting pitting corrosion occurring on both specimens. Nevertheless, we could still find the difference in between. The anodic current density for the sample HP620 is one order of magnitude higher than that for HP560. Besides, a negative shift of nearly 100 mV of the corrosion potential  $E_{\text{corro}}$  for the HP620 is observed. The tests suggest that the corrosion susceptibility of the composite HP620 is remarkably higher.

Potentiodynamic polarization tests were also performed in the H<sub>3</sub>BO<sub>3</sub> solution with addition of 600-ppm Cl<sup>-</sup>. In the presence of Cl<sup>-</sup>, both the samples underwent severe corrosion attack. From the anodic branches of the polarization curves, it is observed that the anodic

current density sharply increases to near 10 mA/cm<sup>2</sup>. The comparatively higher current density for the sample HP620 also suggests the higher corrosion rate.

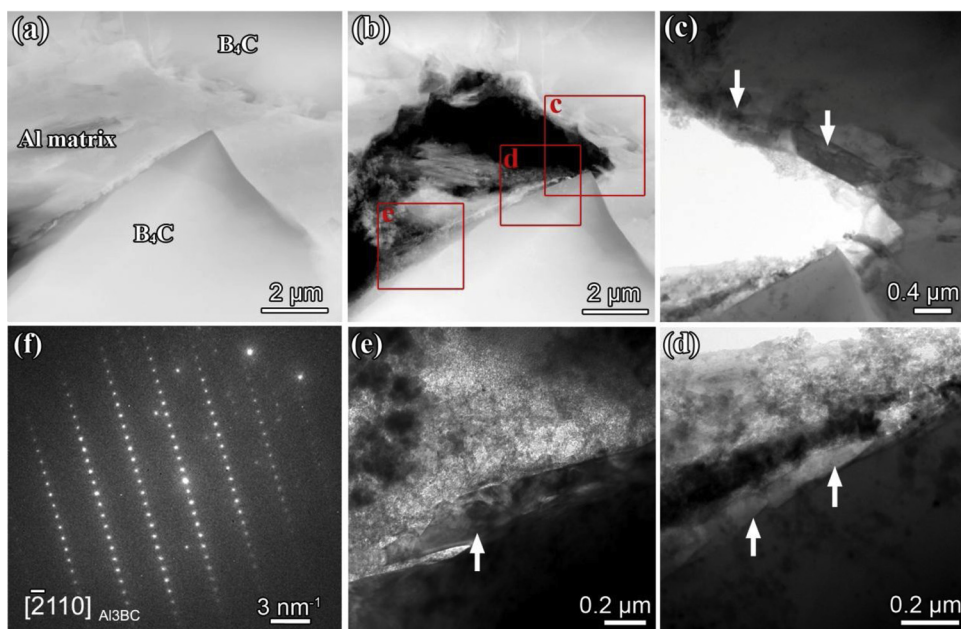
**Fig. 12.** Quasi in-situ TEM observation of the pitting at the  $B_4C/Al$  interface in the sample HP620. (a) and (b) HAADF images of the  $B_4C/Al$  interfaces before and after immersion in  $Cl^-$ -containing  $H_3BO_3$  solution (2 h), respectively. A large pit formed between the neighboring  $B_4C$  particles. (c), (d) and (e) High-magnification BF-TEM images of the areas corresponding to the frames in (b). As arrowed,  $Al_3BC$  particles are observed. (f) SAED pattern of the  $Al_3BC$  particle in (e) showing it did not undergoes corrosion.

As a comparison, quasi in-situ TEM observations were carried out on the composite HP620 as well. Pitting at the  $B_4C$ /Al interface could also be found. As shown in Fig. 12(a) and (b), a pit is seen between the two neighboring  $B_4C$  particles. The lower  $B_4C$  particle possesses a sharp corner and the dissolution of aluminum matrix seems to initiate at the corner which was totally exposed in the dissolved pit. The high-magnification bright-field micrographs of the areas framed in Fig. 12(b) are displayed in Fig. 12(c)–(e). As marked by white arrows,  $Al_3BC$  particles remain on the  $B_4C$  surfaces. The electron diffraction performed on the  $Al_3BC$  in Fig. 12(e) is shown in Fig. 12(f). The perfect crystalline characteristic indicates that the compound was unattacked during the corrosion process.

Being distinct with the ‘clean’  $B_4C$ /Al interface in the sample HP560, the MRR at the  $B_4C$ /Al interface in the HP620 generate a semiconductor  $Al_3BC$  layer. It obviously increases the complexity of the galvanic system. Firstly, as shown in Fig. 12, the  $Al_3BC$  compound in the corrosion pit does not show any degradation, indicating its higher corrosion potential than the aluminum. It possibly acts as a new cathode whose effect depends on its electrode potential and the cathodic reaction kinetics on its surfaces. Secondly, the junction
