Materials Science and Engineering A 491 (2008) 131-136

# Crack initiation mechanism of extruded AZ31 magnesium alloy in the very high cycle fatigue regime

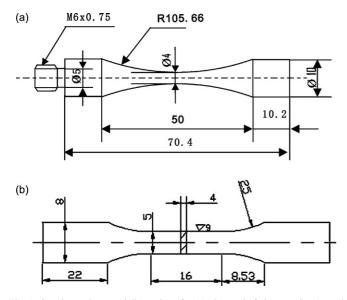
Fig. 1. Specimen shape and dimensions for (a) ultrasonic fatigue testing (round specimen) and (b) conventional fatigue testing (plate specimen), respectively.

The dimensions of the specimens for ultrasonic and conventional fatigue tests are shown in Fig. 1. Both tests were performed at room temperature and in ambient air. Ultrasonic fatigue testing was conducted on Shimadzu USF-2000 testing system with a resonance frequency of 20 kHz, a resonance interval of 150 ms and a stress ratio of R = -1. Specimens were polished by emery paper and then buff-finished before fatigue testing. During the ultrasonic fatigue testing process, specimens were cooled by compressed air and were cycled at constant stress amplitude to  $10^9$  cycles except failure. Some specimens were then cut along the direction parallel to the gage length and prepared for optical microscope observation. Details of ultrasonic fatigue testing procedures and systems are described elsewhere [11]. Conventional servo-hydraulic fatigue testing was conducted on Instron 8871 fatigue testing machine with a frequency of 1 Hz and a load ratio of R = -1. Electro-polished plate specimens were prepared for the purpose of surface observation. Specimens were first loaded under the stress amplitude of 90 MPa (in the stress range of ultrasonic fatigue loading) for 10<sup>4</sup> cycles without failure. After surface analysis, these specimens were further cycled

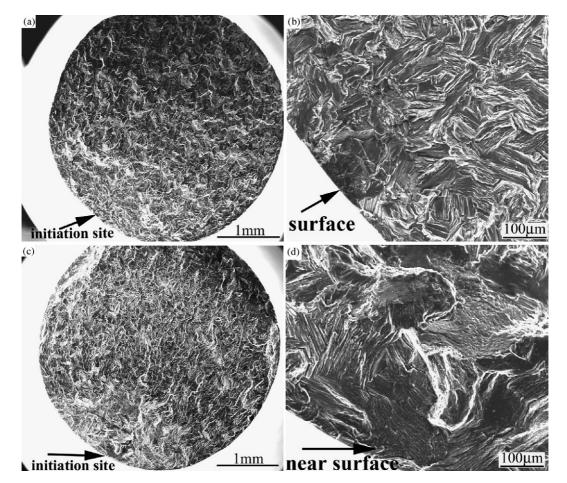
Fig. 3. Low (a and c) and high (b and d) magnification SEM images for fracture surfaces of AZ31 alloy after ultrasonic fatigue loading. Arrows indicate crack initiation from surface (a and b) or from near surface (c and d).

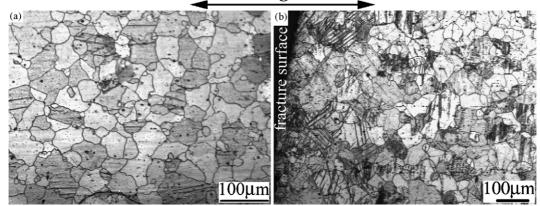
Fig. 5. Optical images of microstructures on the specimen section parallel to the gauge length (a) before and (b) after ultrasonic fatigue testing, respectively; (b) the area right below the fracture surface. Loading axis direction was marked.

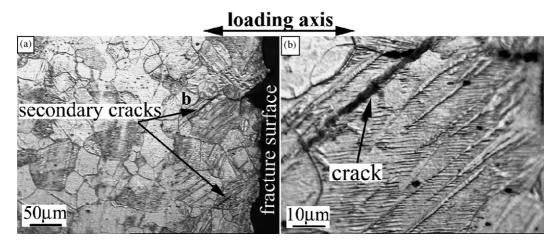
Fig. 6. Optical images of the specimen section parallel to the gauge length beneath the fracture surface (ultrasonic fatigue,  $\pm 100 \text{ MPa}$ ,  $1.032 \times 10^8$  cycles): (a) secondary cracks formed along twin bands; (b) magnified image of the crack marked b in (a). Loading axis direction was marked.

Fig. 6 shows the microstructures of ultrasonic-fatigued specimen from the section parallel to the gauge length beneath the fracture surface. Arrows in Fig. 6(a) indicate that secondary cracks were formed along twin bands. Fig. 6(b) is the magnified image of the upper crack marked b in Fig. 6(a). For ultrasonic fatigue testing generally running in the very high cycle regime, crack initiation may take up most of the total fatigue life [13]. That is to say, once the crack has initiated, the specimen will break up very soon. Besides, due to the requirements of our ultrasonic fatigue equipment, only round specimens (Fig. 1(a)) were used for this test. Therefore, it is hard to observe crack initiation sites from specimen surfaces in the ultrasonic fatigue test and it is hard to track down the main crack initiation sites from the observation of specimen section parallel to the gauge length as shown in Fig. 6. However, fatigue damage was not just confined on the main cracking layer; thus the observation of secondary cracks beneath the fracture surface could also provide us with a good understanding that twin has played an important role in the process of fatigue crack initiation.

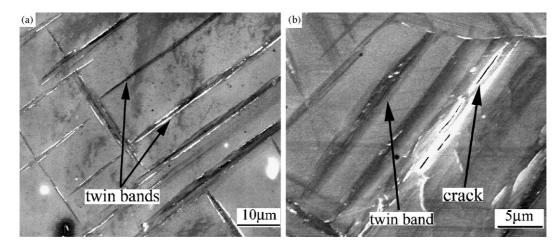
Fig. 7. SEM images of specimen surface after conventional fatigue loading: (a) deformation twins were visible after  $10^4$  cycles (conventional fatigue,  $\pm 90$  MPa); (b) microcracks were found to initiate along twin bands after further fatigue under  $\pm 120$  MPa as indicated by arrow.

On the other hand, conventional fatigue testing could help us further confirm the crack initiation mechanism. In Fig. 7, surface morphologies for specimen after conventional fatigue loading are shown. After  $10^4$  cycles of fatigue under the stress amplitude of 90 MPa, twins were formed on specimen surface, but cracks have not been seen (Fig. 7(a)), which is reasonable since the life span of  $10^4$  is negligible compared to the general life span of the very high cycle fatigue. Further fatigue loading under the stress amplitude of 120 MPa for several thousand cycles led to crack initiation along some twin bands (Fig. 7(b)). Although ultrasonic fatigue damage process cannot be duplicated simply by conventional fatigue process, the results obtained in Fig. 7 could still reflect that twin has played an important role in crack initiation in the very high cycle fatigue regime.
